**FATIGUE BEHAVIOR OF AN ADVANCED SiC/SiC COMPOSITE
AT ELEVATED TEMPERATURE IN AIR AND IN STEAM**

THESIS

AFIT/GAE/ENY/09-D02

AIR FORCE INSTITUTE OF TECHNOLOGY

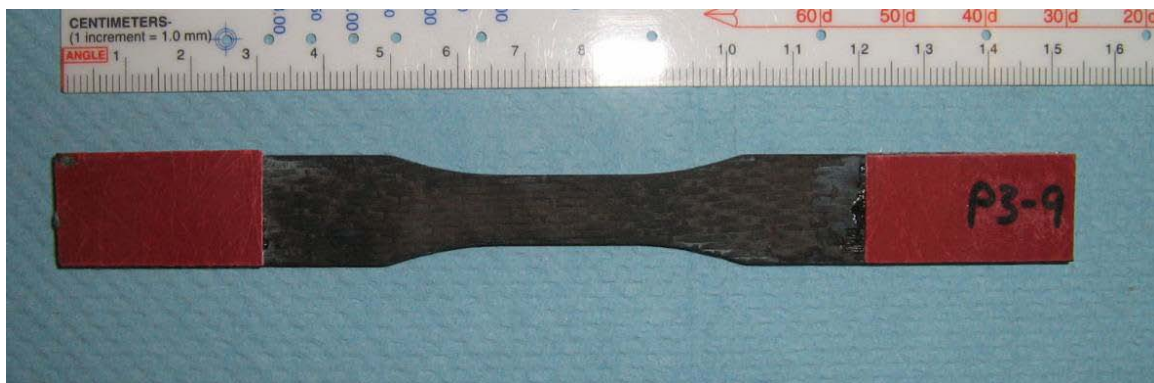
Figure 10: Hi-Nicalon/BN/SiC test specimen.

Bomas Machine Specialties, Inc. used diamond grinding to “cut” the parent panels into standard AFIT tensile test specimens according to the specifications shown in Figure 9. To prevent fraying of the test specimen edges during machining, the parent material was sandwiched between pieces of sacrificial material. Following machining, the test specimens were returned to the manufacturer for a seal coating through an additional SiC CVI treatment. Prior to testing, fiberglass tabs were glued onto both sides of each end of the test specimens to protect the ends from being crushed by the hydraulic grips of the test machine. Throughout machining, sealing, and testing, strict documentation and control ensured traceability of each test specimen back to its parent panel. A specimen ready for testing is shown in Figure 10.

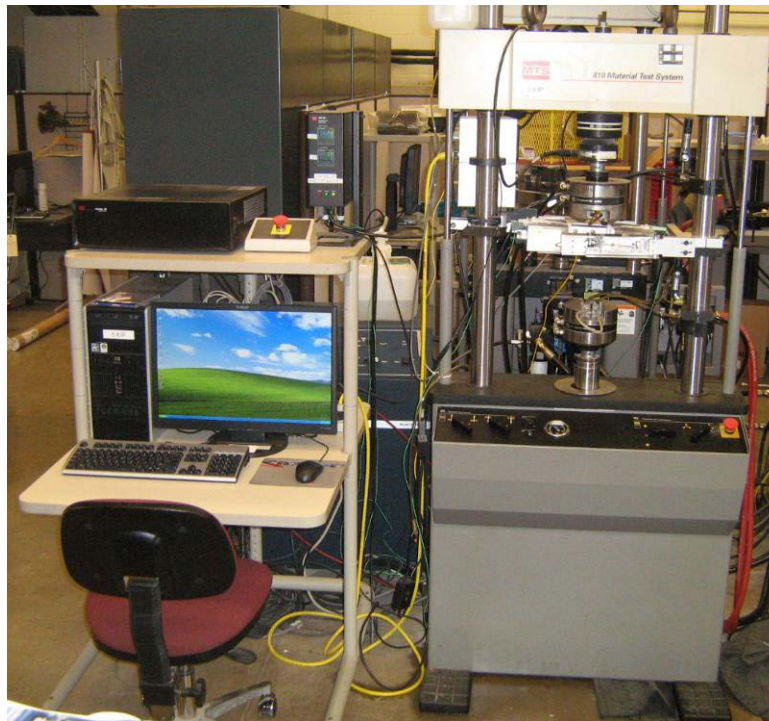
Figure 11: MTS 5 kip vertical servo hydraulic test stand.

Testing of the Hi-Nicalon/BN/SiC employed several pieces of equipment in AFIT's mechanical testing laboratory. The primary testing machine was the Material Test Systems (MTS) vertical servo hydraulic test stand with a 25 kN (5.5 kip) load cell, hereafter referred to as the 5 kip machine. Test specimens were mounted into the 5 kip machine via MTS 647 hydraulic, water cooled, wedge grips. Grip pressure was set to 8 MPa. This grip pressure was high enough to prevent slipping during the tests yet low enough not to crush the specimens. Machine alignment was maintained with an MTS 609 alignment fixture. Figure 11 shows the 5 kip machine.

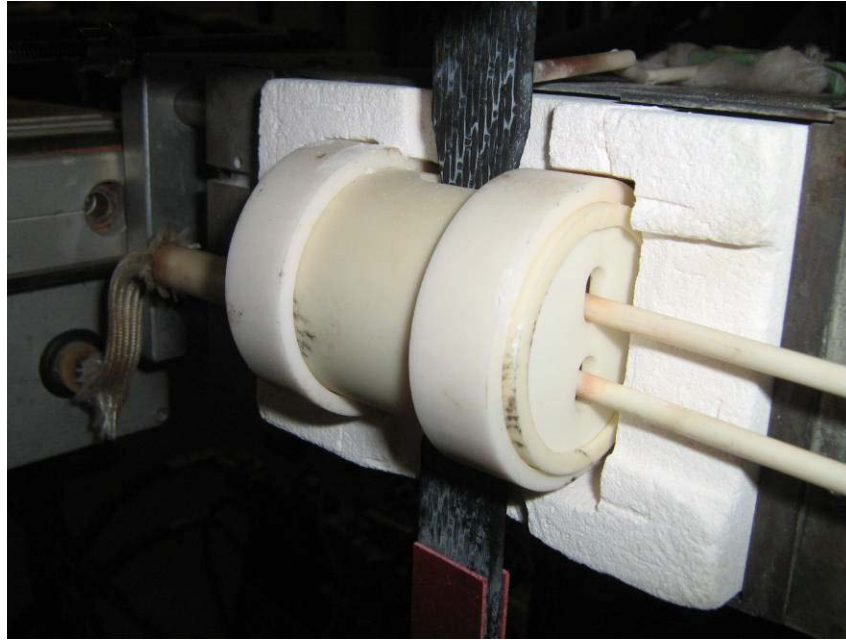
Figure 14: Test specimen mounted in Alumina susceptor.

Tests in steam employed an alumina susceptor (a tube with end caps), which fits inside the furnace. The specimen gage section fits inside the susceptor with the grips ends of the specimens passing through slots in the susceptor. Steam was generated by an AMTECO Steam Generator and introduced into the susceptor in a continuous stream with a slightly positive pressure creating a near 100% steam environment inside the susceptor (Figure 14). Cooling water held at 15°C by a NESLAB Coolflow Model HX-75 refrigerated re-circulator and pumped through the wedge grips protected them from the heat of the furnace during testing.

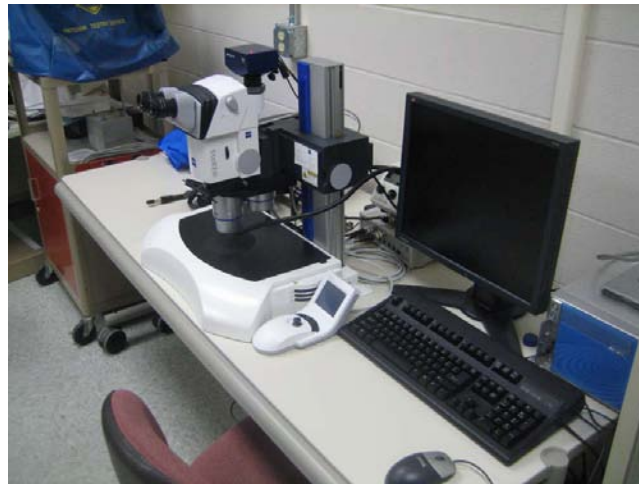
Figure 15: Zeiss Stemi SV II optical microscope with a Zeiss AxioCam HRc digital camera.

After testing, the failed samples were examined under 1) a Zeiss Stemi SV II optical microscope equipped with a Zeiss AxioCam HRc digital camera (Figure 15)

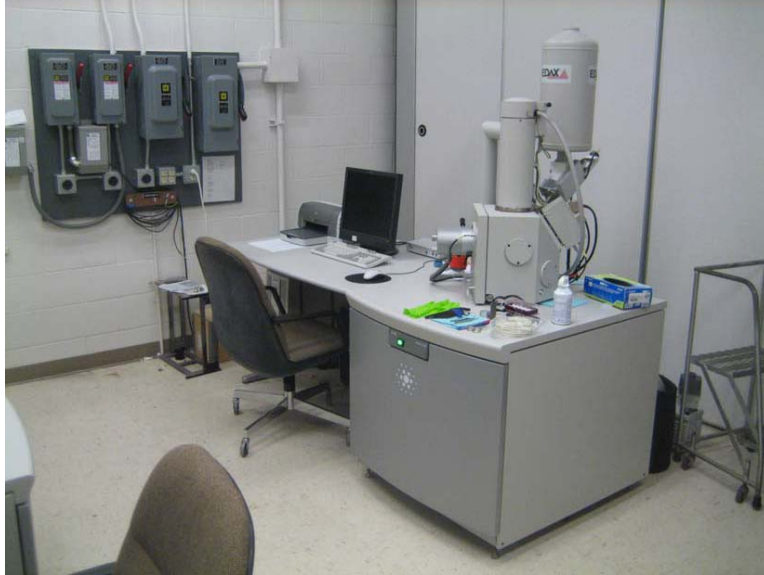
Figure 16: Quanta 200 Scanning Electron Microscope.

And 2) the Quanta 200 scanning electron microscope (Figure 16).

The failed specimens were cut ~4mm behind the fracture surface, and then the fracture surface was mounted on a metallic SEM sample tab. Viewing these specimens at progressively tighter magnifications allowed analysis and characterization of the fracture surface.

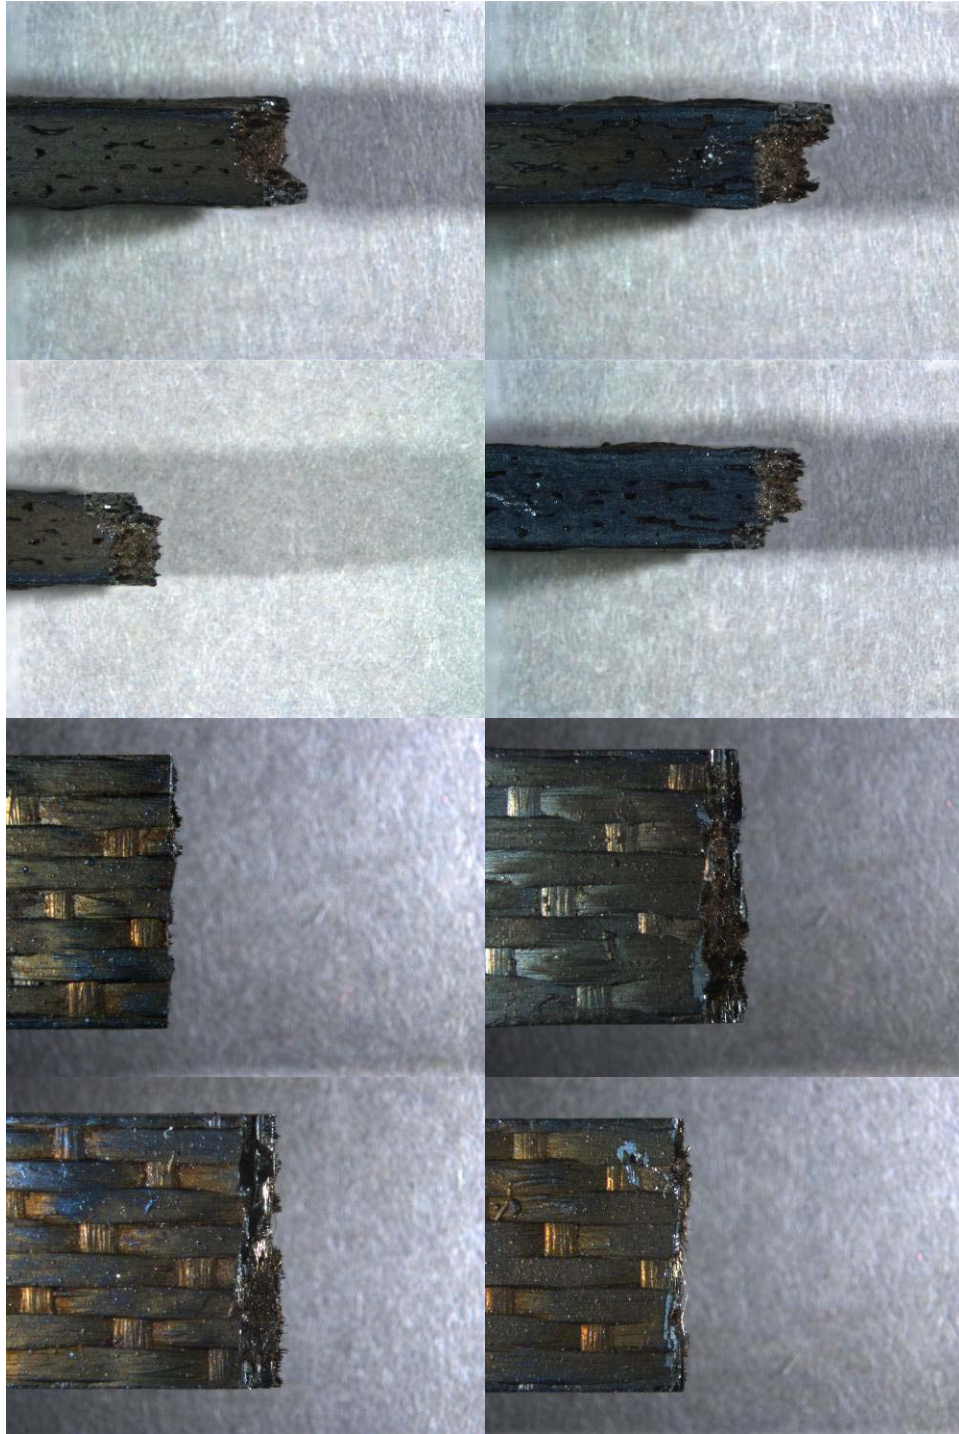
Figure 80: Optical Micrographs of the fracture surfaces produced in tensile test to failure conducted at 0.05mm/sec at 1200 °C in air on specimen P1-3.
